# CHAPTER 18: LEAD HAZARD CONTROL AND HISTORIC PRESERVATION

# Lead Hazard Control in Historic Buildings: How To Do It

# Chapter 18: Lead Hazard Control and Historic Preservation

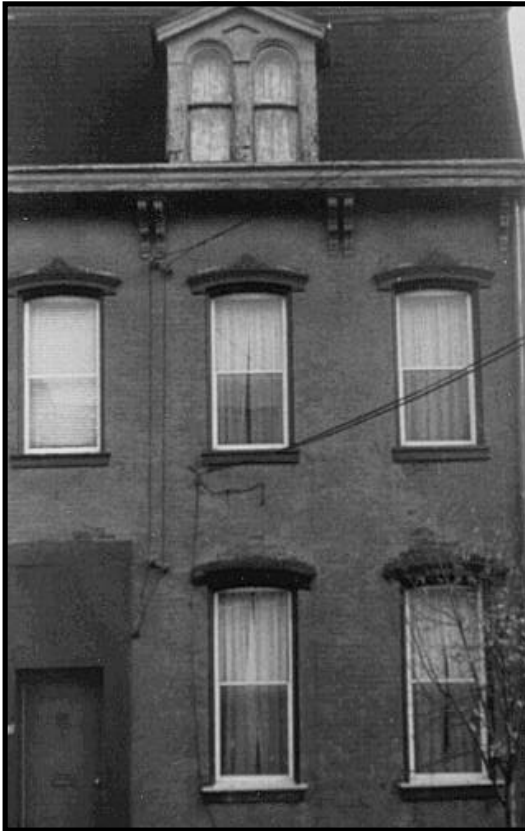
Figure 18.1 Historic Property Before Lead-Based Paint Was Chemically Removed From Exterior Masonry.

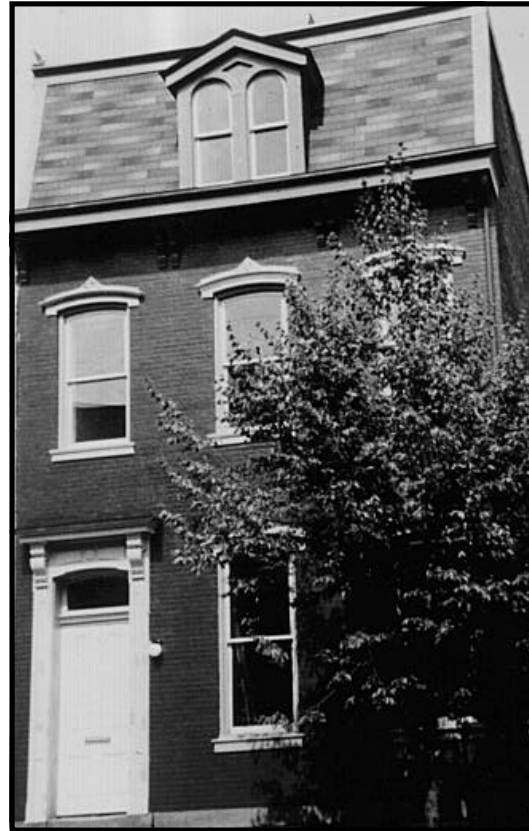
Figure 18.2 Historic Property After Lead-Based Paint Was Chemically Removed.

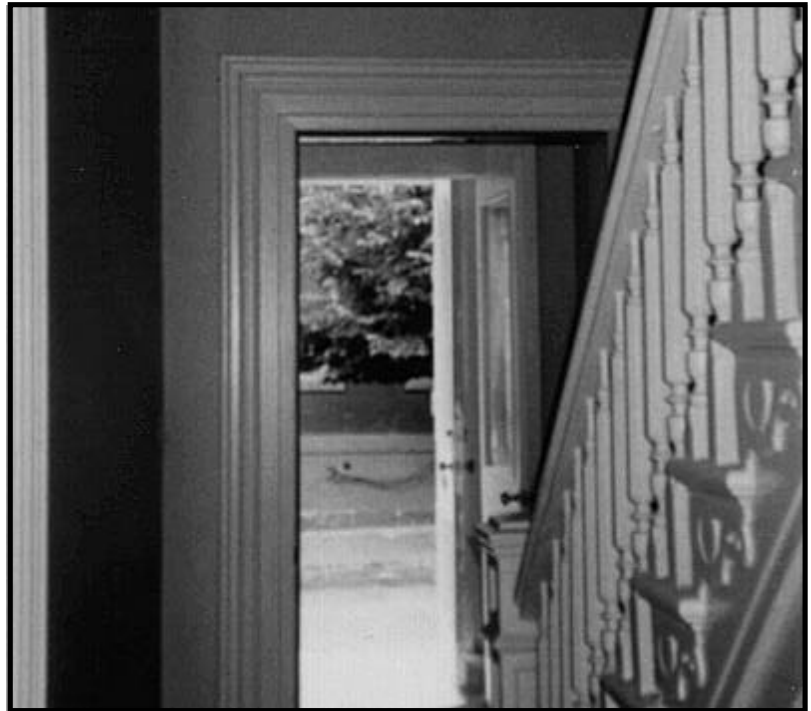
Figure 18.3 Historic Property Where the Interior Woodwork and Staircase Were Wet Sanded and Recoated With Three Layers of Encapsulant To Preserve the Carved Profiles.

Interior trim: All historic wooden trim remained in place and was repainted with special encapsulant coatings after wet sanding to remove loose lead-based paint. The ornate banister and handrail that had potentially chewable surfaces, were painted with three light coats of encapsulant to protect the decorative details and to avoid loss of detail due to the thickness of the paint.

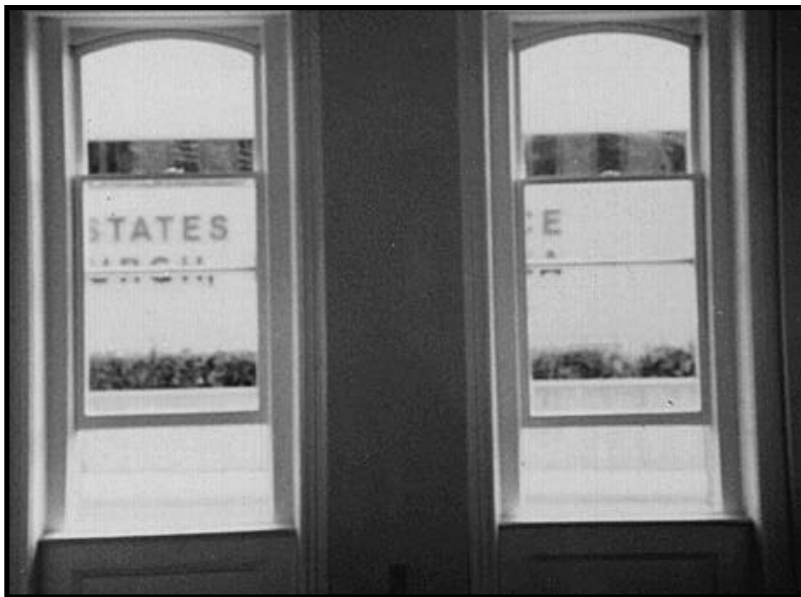
Figure 18.4 Deteriorated Window Sashes Were Replaced in This Historic Property While the Frames and Trim Were Wet Sanded and Repainted (vinyl liners were also installed as a friction reduction treatment).

Windows: The window sashes were replaced with new sash matching the visual configuration of the historic sash which included an arched upper portion. The historic frames remained in place and received vinyl jamb liners to eliminate friction surfaces. The project was scheduled to have the window frames on the exterior boxed out and clad in white aluminum, but this treatment was eliminated after consultation with the State Historic Preservation Office because it would have altered a significant architectural feature on the primary facade. To preserve the distinctive bullnose moldings of these exterior frames, it was determined that the wood could either be wet sanded or chemically stripped to remove paint and repainted with oil/alkyd paint, or repainted with encapsulant paint coatings after stabilizing existing lead-based paint. Repainting with oil/alkyd after a mild chemical cleaning was selected for the exterior frames.
