## Layer 5 (top layer) Stratigraphy Card

**Site Feature, Layer 5 - Foundation Section**

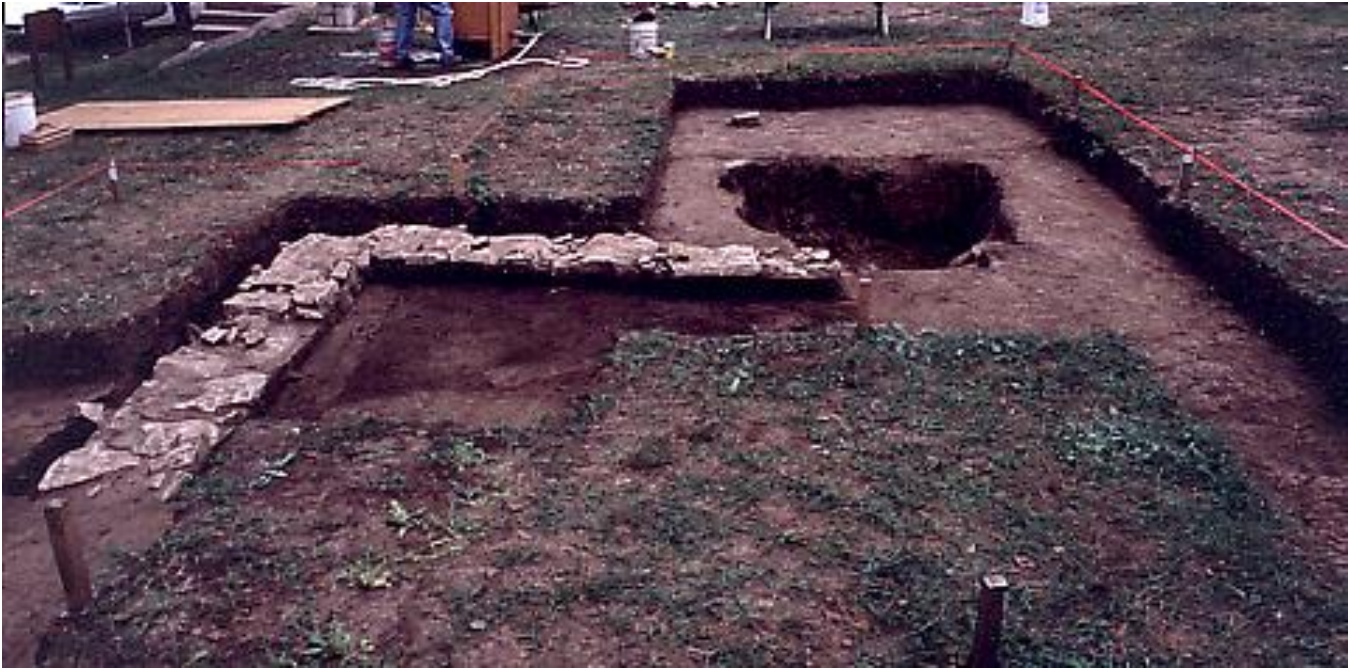
This manmade stone alignment appears to be part of a building foundation, the base upon which a structure is built. The irregular size of the stones and the shallow depth of their placement suggest that the foundation supported a fairly small, temporary structure.

The construction materials (quarried limestone) and techniques (laid with mortar) used in creating this foundation indicate relatively recent construction by European-American builders. Native American dwellings tend to be round, or rectangular with rounded corners; right angles are quite rare. European-American settlement began in earnest after Kansas became a territory in 1854. The materials, technology, and skills needed to create this foundation are still available, and a structure with this type of foundation could be built today.
